Project  
**MANUEL L.G.  
 SAN NICOLAS HOUSE  
 LOT 73, INARAJAN**

# MANUEL L. G. SAN NICOLAS HOUSE

Title  
FLOOR PLAN  
(EXISTING CONDITION)  
BUILDING ELEVATIONS  
(EXISTING CONDITION)

Title  
DESCRIPTION OF WORK  
SECTIONS

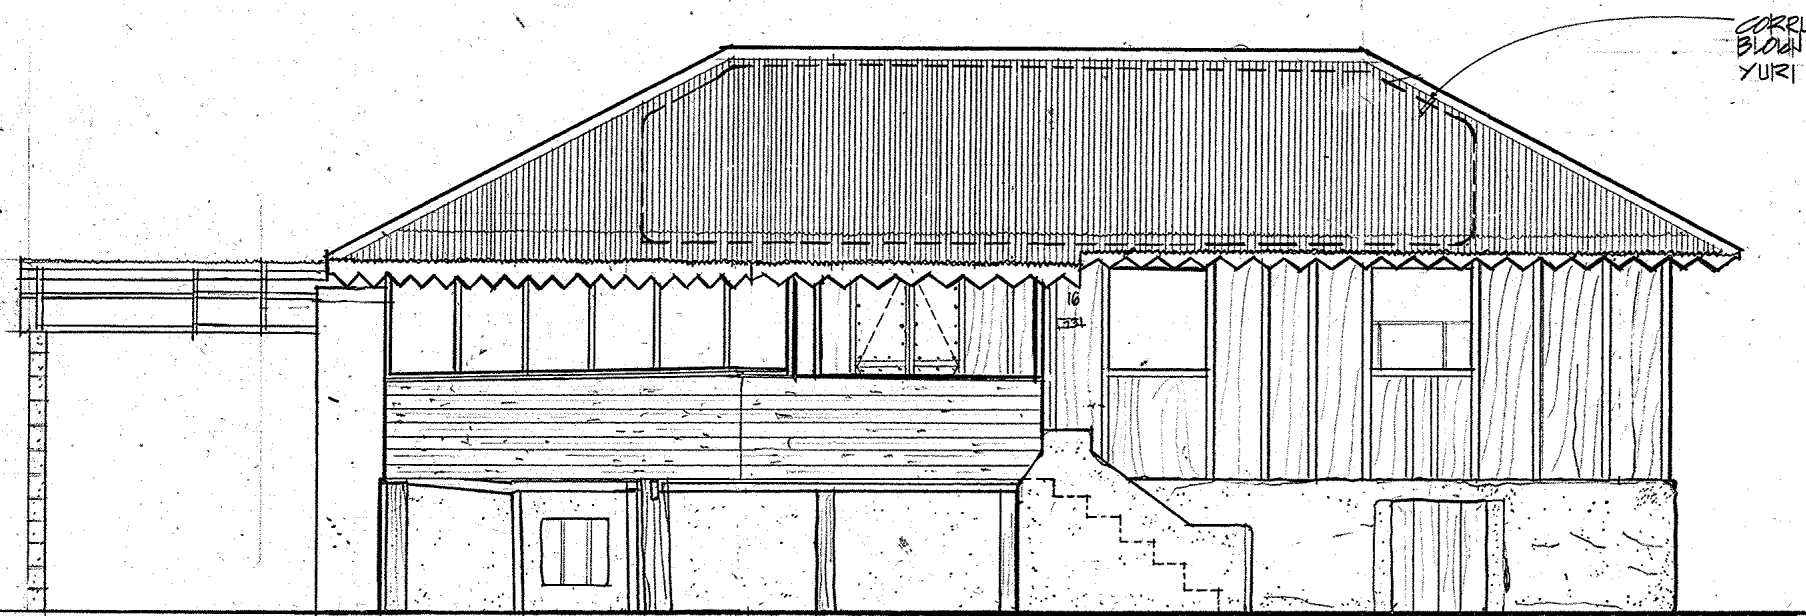
**FRONT ELEVATION**

CORRUGATED MTL ROOFING  
BLOWN OFF BY TYPHOON  
YURI (1991)

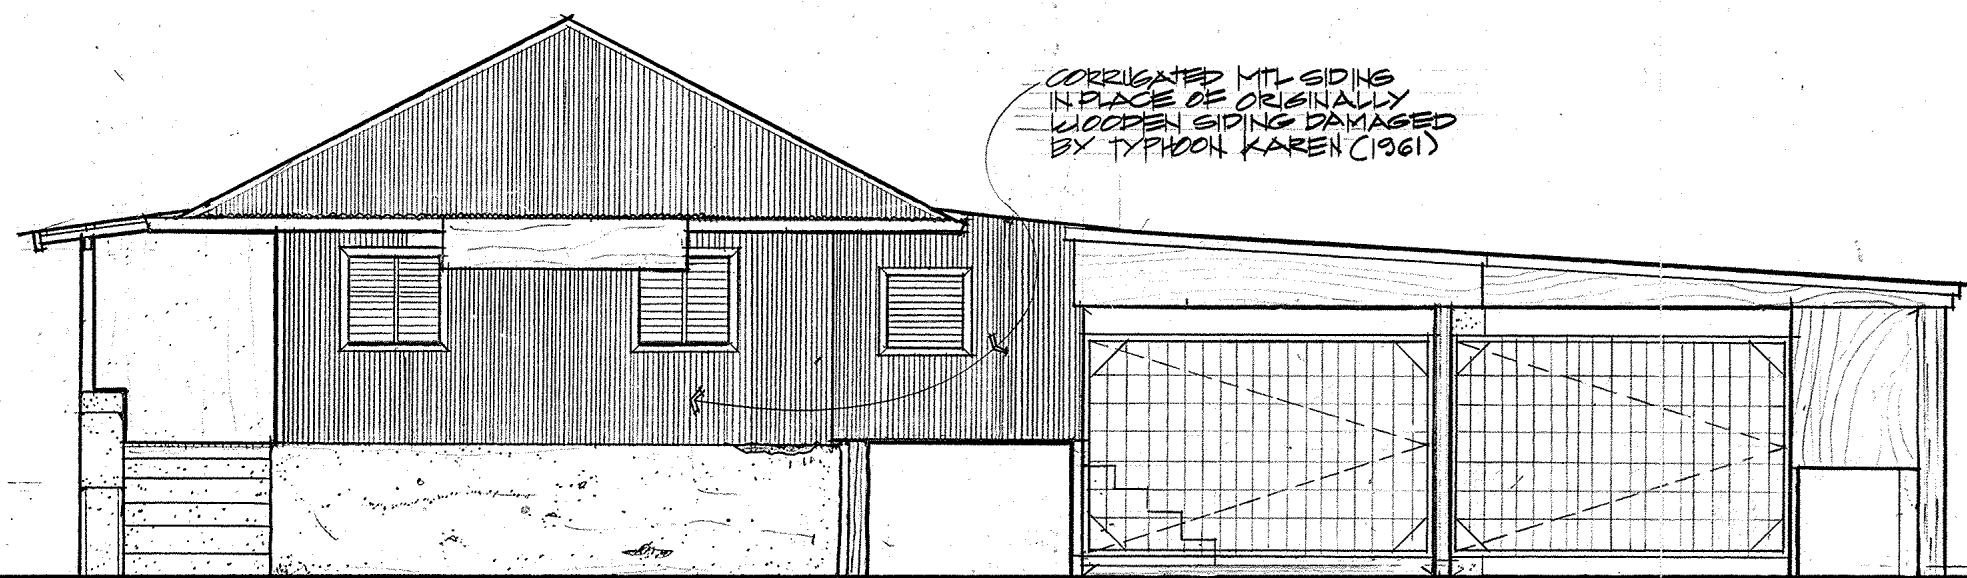
**SIDE ELEVATION**

CORRUGATED MTL SIDING  
IN PLACE OF ORIGINALLY  
WOODEN SIDING DAMAGED  
BY TYPHOON KAREN (1961)

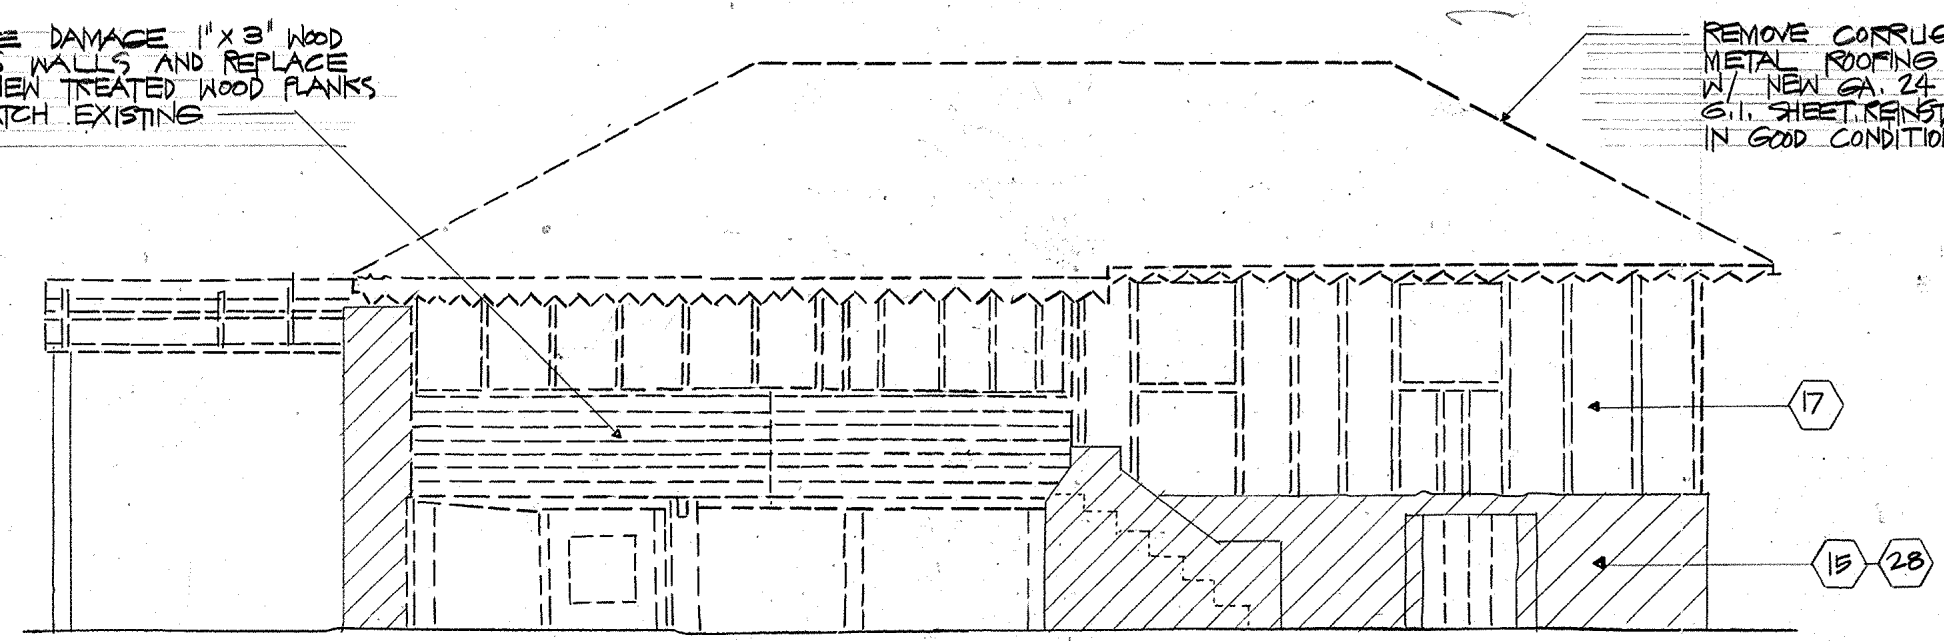
**1A FRONT ELEVATION (EXISTING CONDITION)**  
SCALE: 1/4" = 1'-0"

EXISTING WD. LIVER WDN. (W/ HATCH LINE) TO BE REMOVED

REMOVE DAMAGE 1" x 3" WOOD PLANKS WALLS AND REPLACE WITH NEW TREATED WOOD PLANKS TO MATCH EXISTING

REMOVE CORRUGATED DAMAGE METAL ROOFING AND REPLACE WITH NEW GA. 24 CORRUGATED G.I. SHEET REINSTALL EXISTING IN GOOD CONDITION

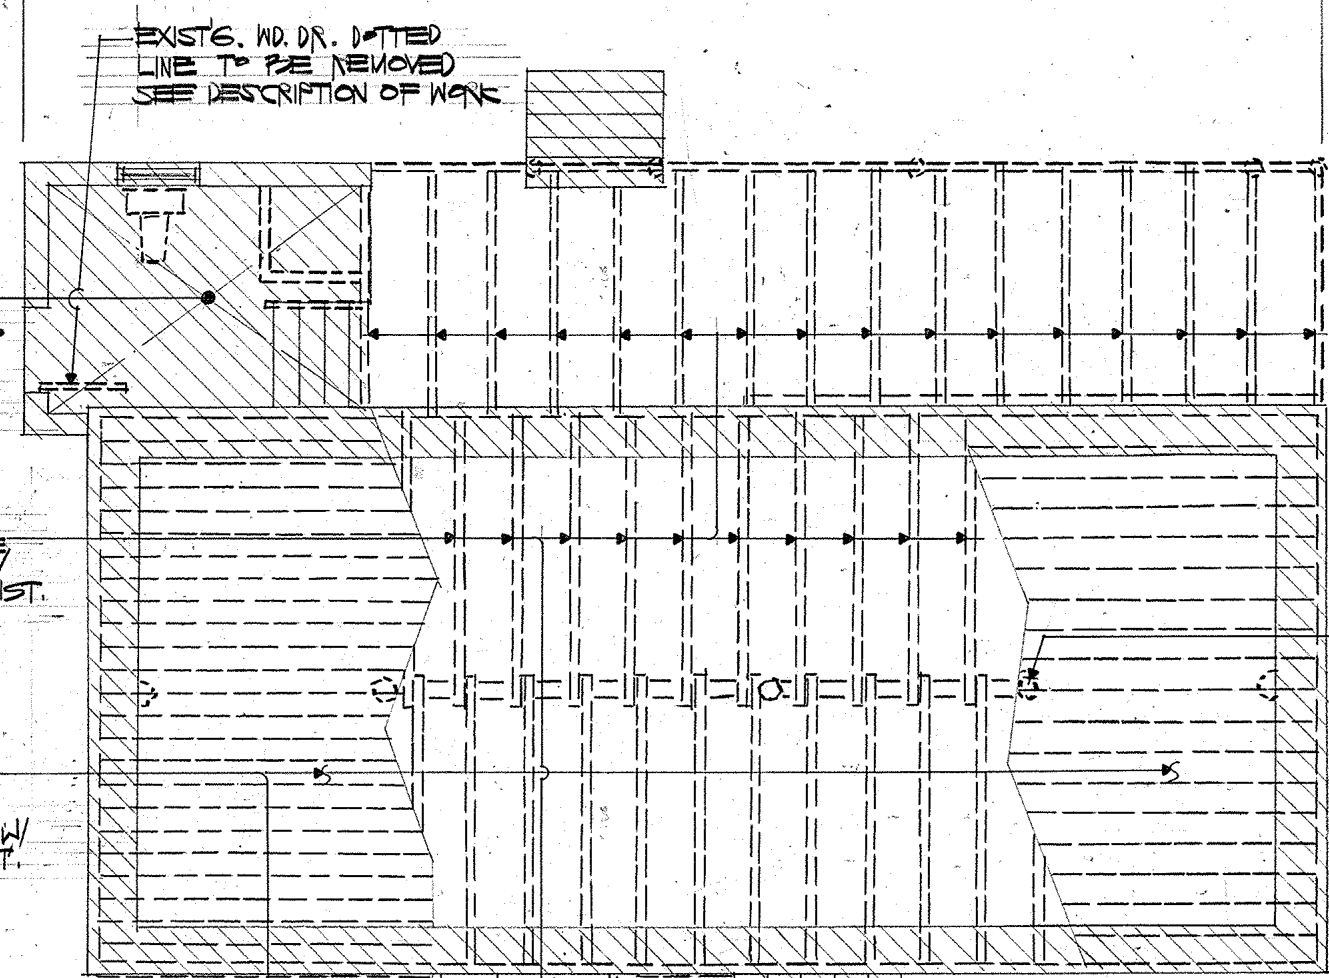
**1 FLOOR PLAN (EXISTING CONDITION)**  
SCALE: 1/4" = 1'-0"

EXISTING TOILET FIXTURE & CER. TILES FLR FINISH TO BE REMOVED & DIS-DESCRIPTION OF WORK

EXISTING FLR JOIST TO REMAIN DAMAGE TO BE REPLACED BY NEW TO MATCH EXIST.

EXISTING HARDWOOD PLANKS TO REMAIN DAMAGE TO BE REPLACED BY NEW TO MATCH EXIST.

EXISTING WD. POST TO REMAIN

EXISTING WD. LIVER WDN. TO BE REMOVED

EXISTING CONC. STAIR (W/ HATCH LINE) TO REMAIN SEE DESCRIPTION OF WORK

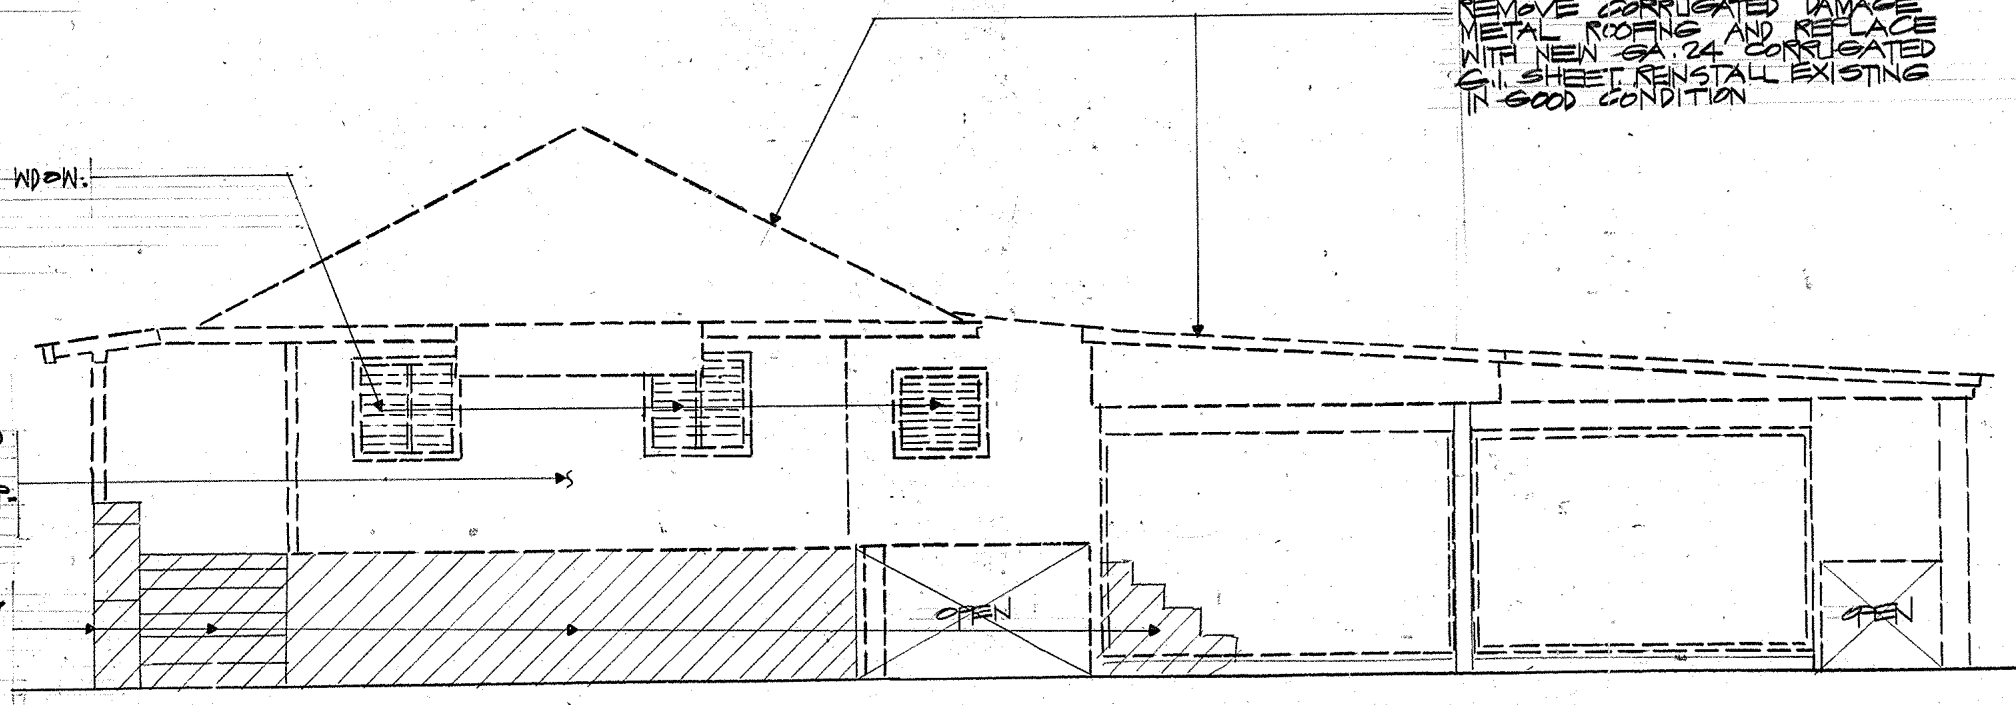
**1C SIDE ELEVATION (EXISTING CONDITION)**  
SCALE: 1/4" = 1'-0"

EXISTING CORRUGATED METL. SIDING TO BE REMOVED. SEE DESCRIPTION OF WORK

EXISTING CONC. STAIR & WALL (W/ HATCH LINE) TO REMAIN SEE DESCRIPTION OF WORK

REMOVE CORRUGATED DAMAGE METAL ROOFING AND REPLACE WITH NEW GA. 24 CORRUGATED G.I. SHEET REINSTALL EXISTING IN GOOD CONDITION

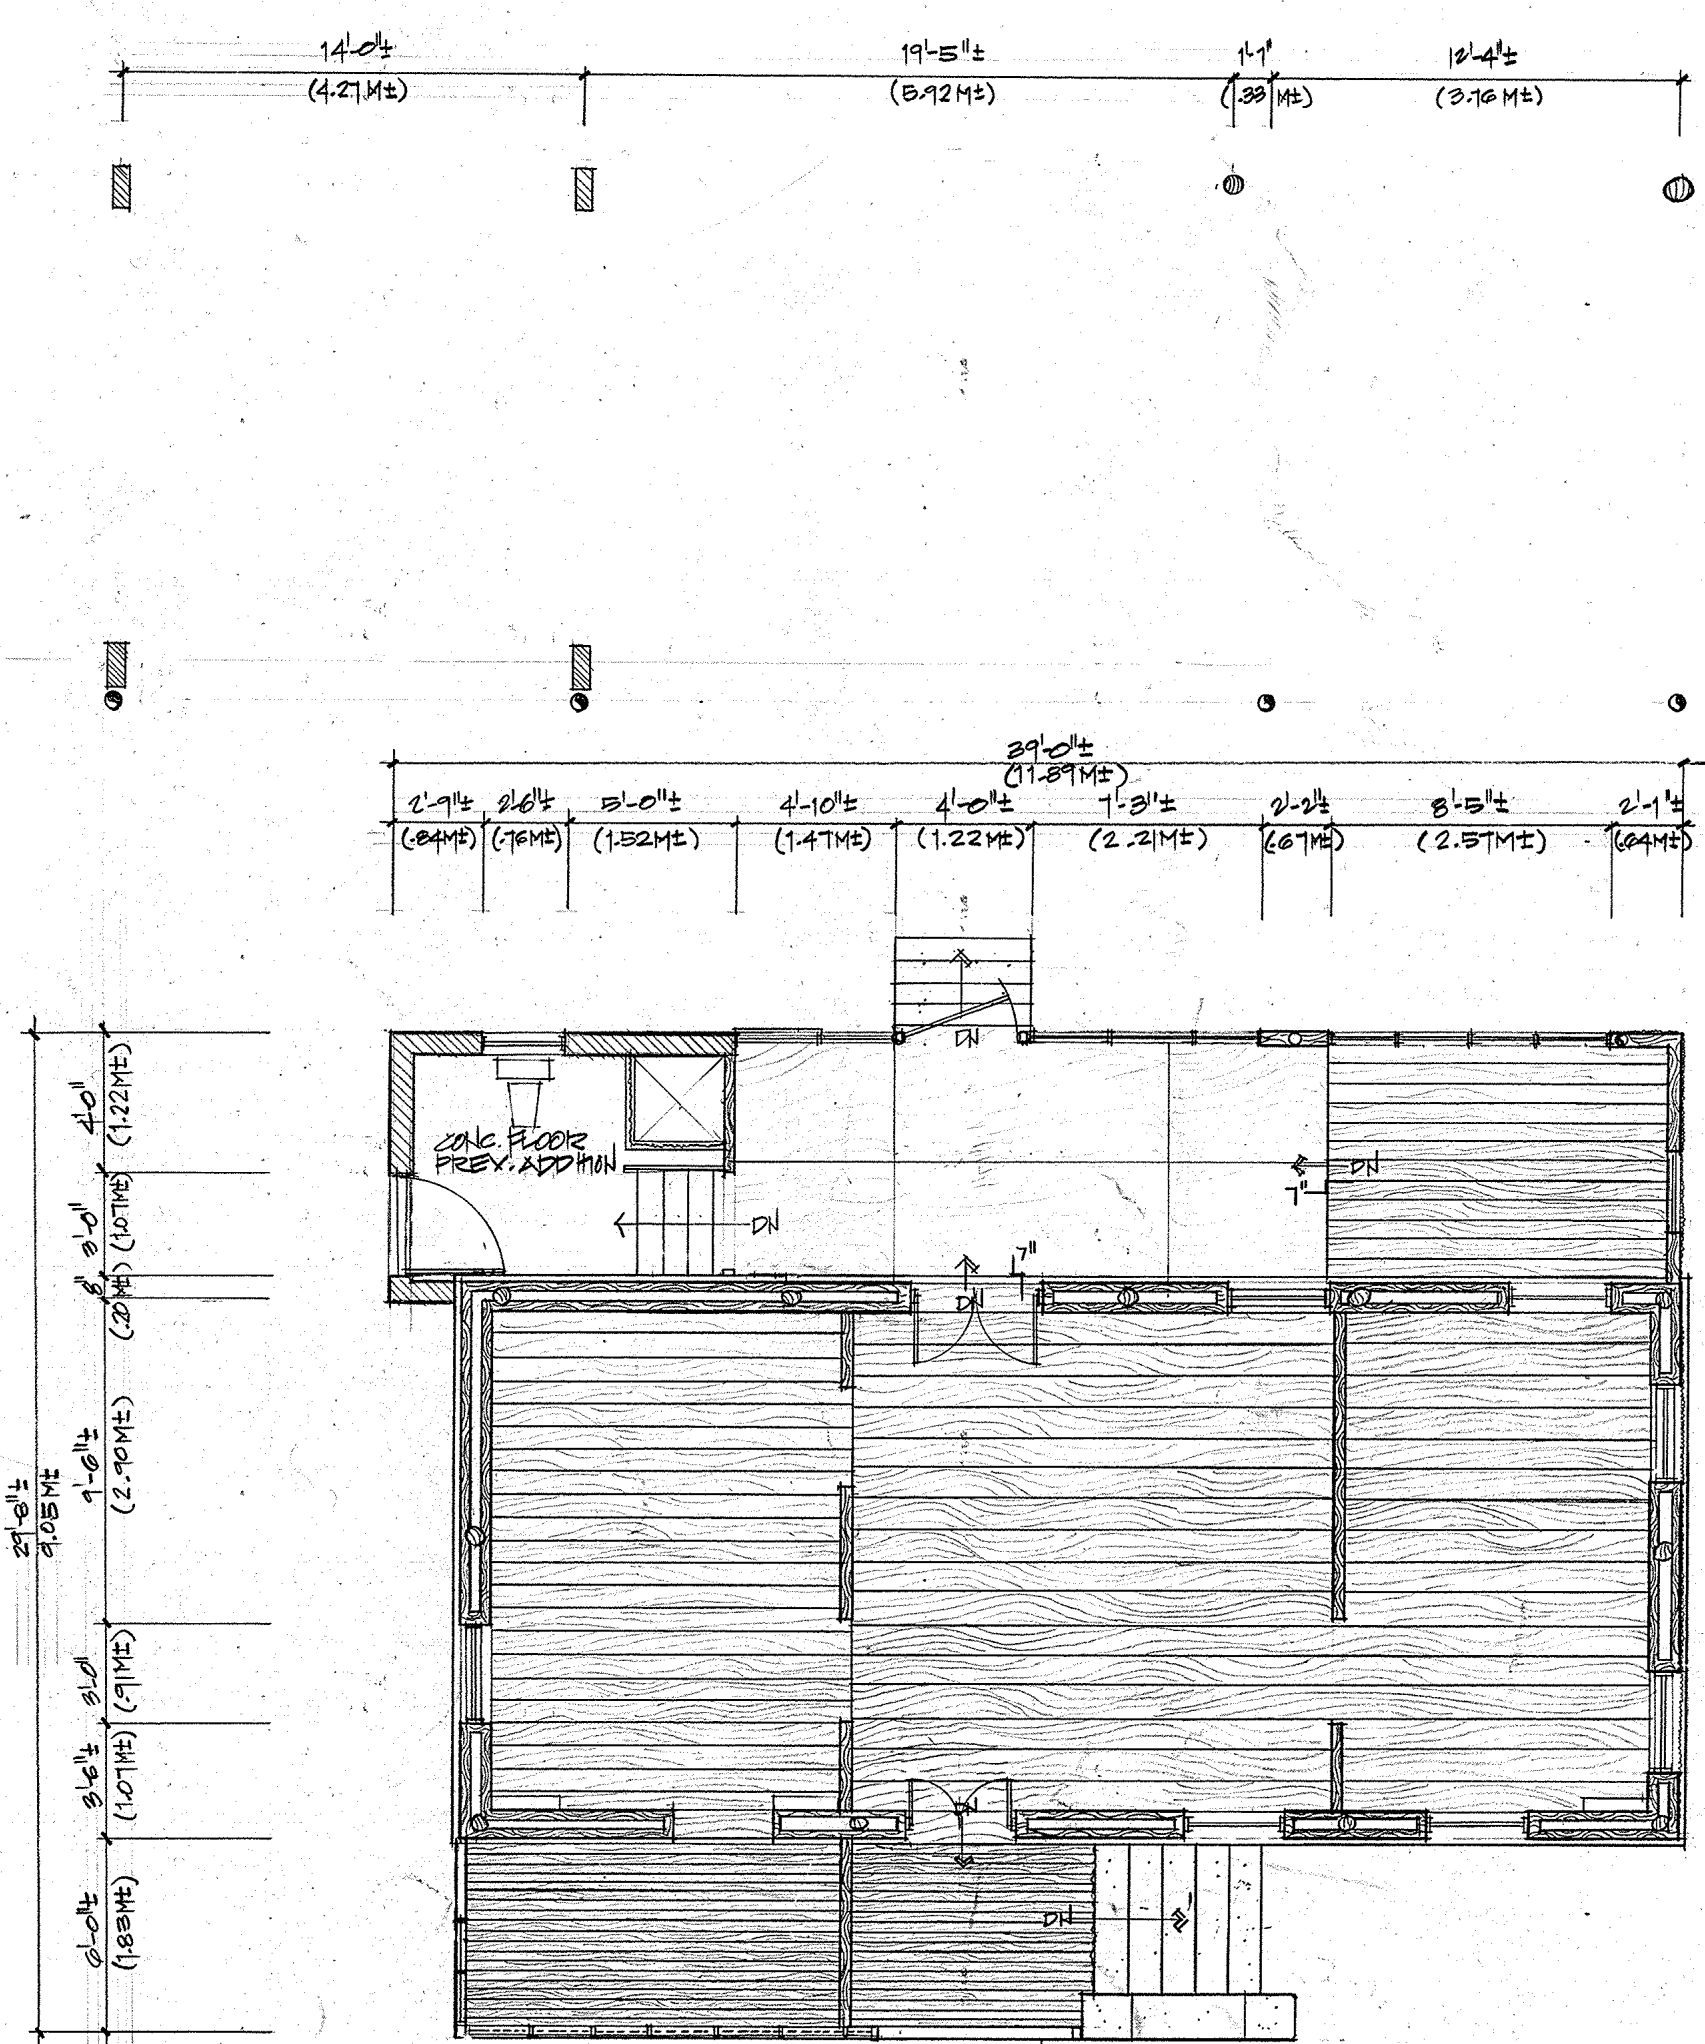
**FLOOR PLAN**  
 SCALE 1/4" = 1'-0"

- ① 1" x 11" HARDWOOD (HIL) PLANKS
- ② 1" x 8" HARDWOOD (HIL) PLANKS
- ③ 1" x 6" HARDWOOD (HIL) PLANKS
- ④ HARDWOOD HIL POSTS
- ⑤ CMU PILES
- ⑥ MTL. PIPE POST
- ⑦ CONC. STAIR
- ⑧ WOOD FINISH PAINTED BOTH SIDES
- ⑨ PLYWOOD

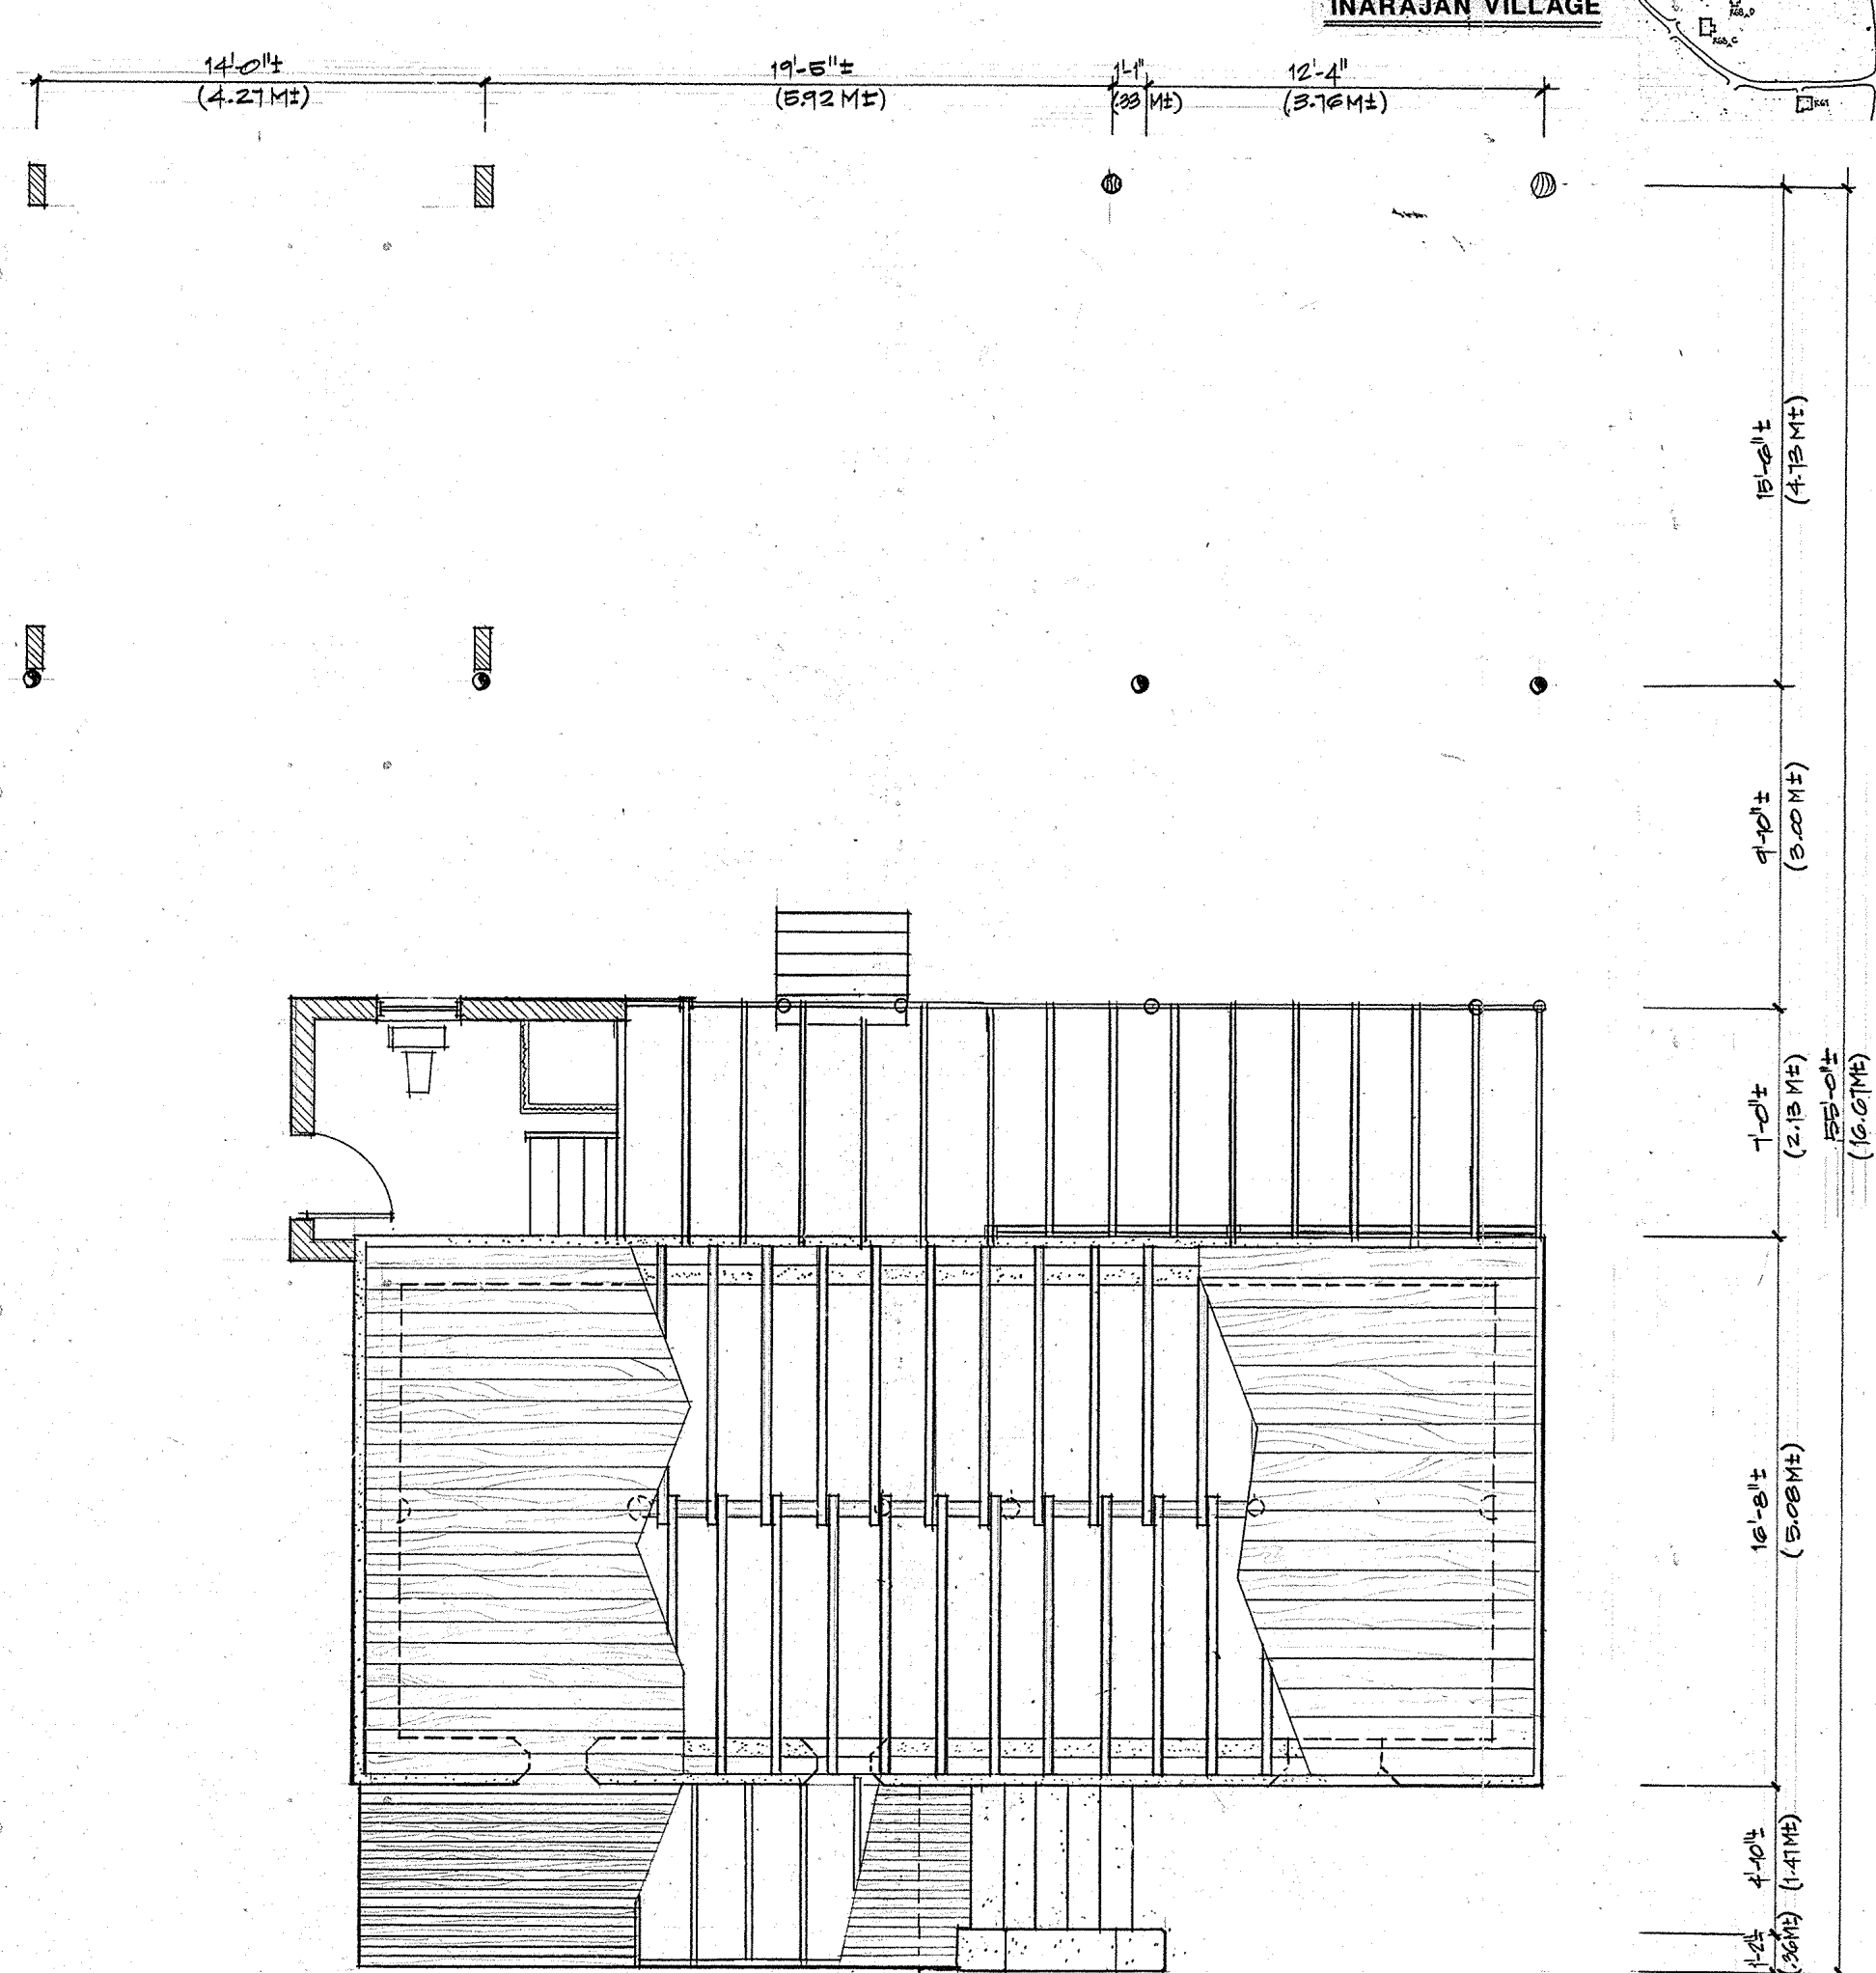
**FLOOR FRAMING PLAN**  
 SCALE 1/4" = 1'-0"

- ① 1" x 11" HARDWOOD (HIL) PLANKS
- ② 1" x 8" HARDWOOD (HIL) PLANKS
- ③ 1" x 6" HARDWOOD (HIL) PLANKS
- ④ HARDWOOD HIL POSTS
- ⑤ CMU PILES
- ⑥ MTL. PIPE POST
- ⑦ CONC. STAIR
- ⑧ RECENT 2" x 4" 2" x 6" FL. JOISTS
- ⑨ 2" x 8" FLOOR JOISTS

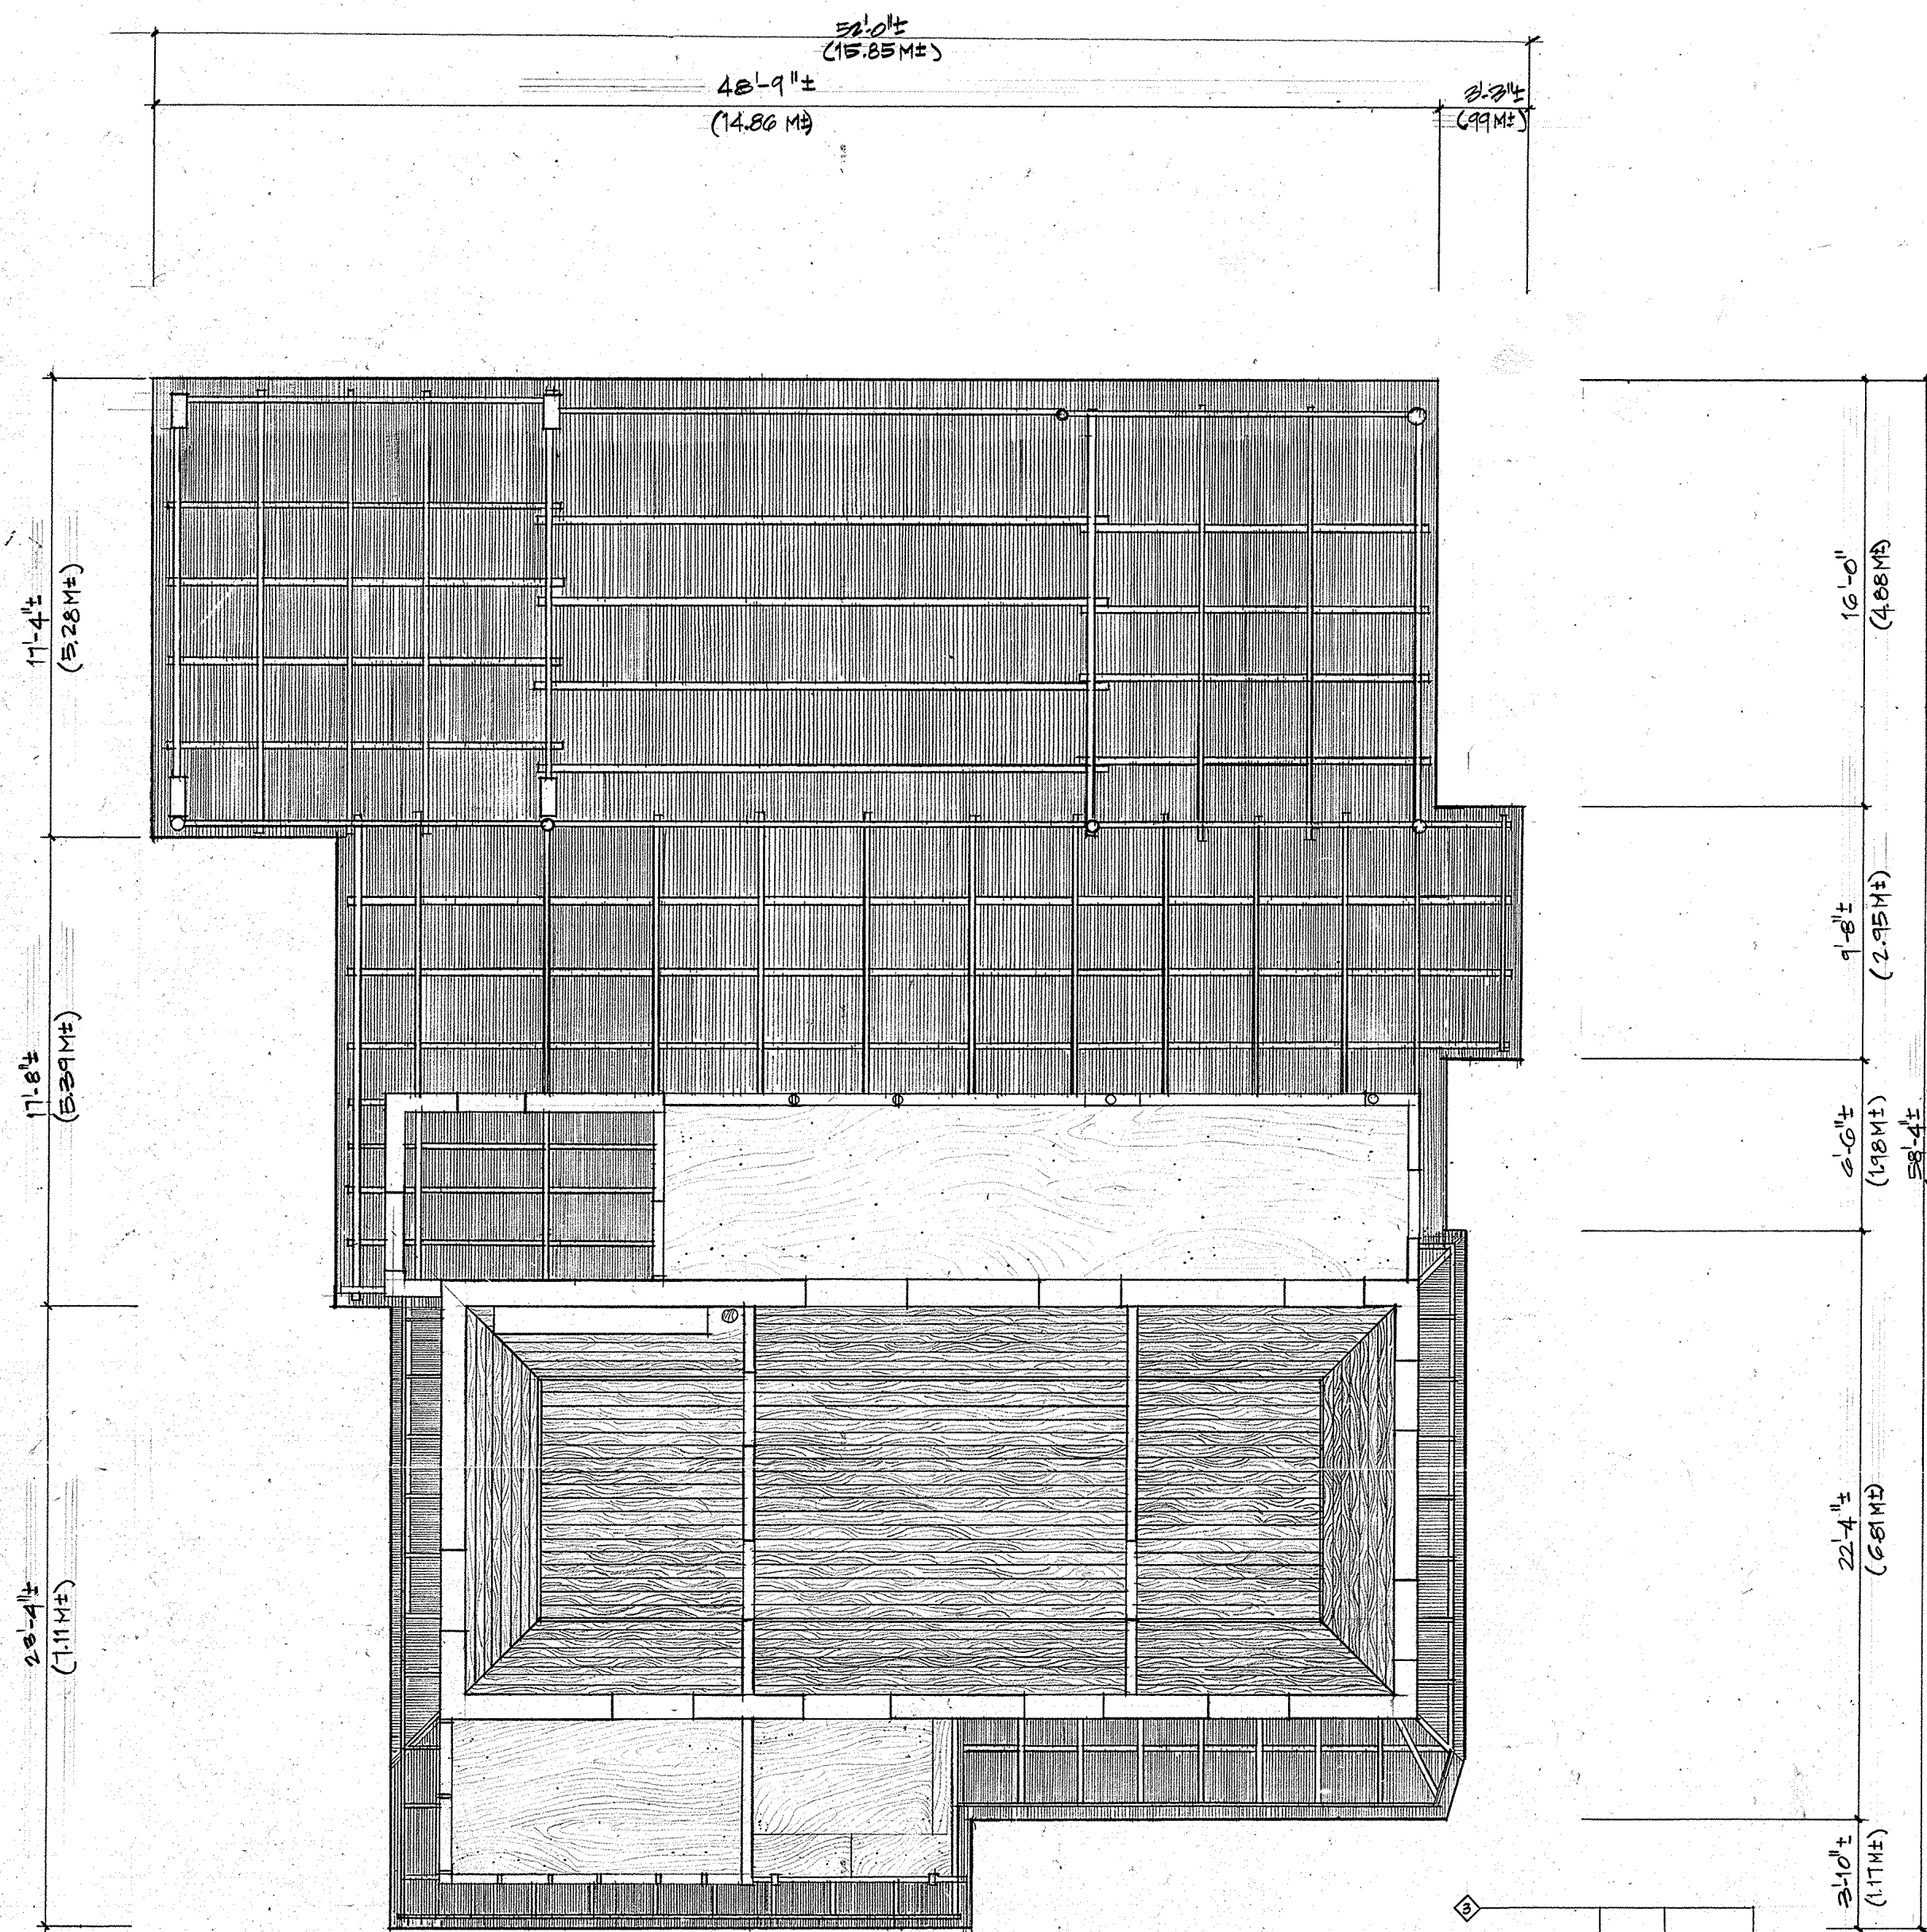
**REFLECTED CEILING PLAN**  
SCALE 1/4" = 1'-0"

- ◇ 2"x8" ROOF JOISTS
- ◇ 2"x4 AND 4"x4 ROOF JOISTS
- ◇ 2"x4 PURLINS
- ◇ 1"x8 WOOD PLANKS
- ◇ PLYWOOD
